## HORICON TOWN BOARD SPECIAL MEETING

JANUARY 16, 2025 4:00 PM

# The Town of Horicon Capital Projects

Gary Ferree

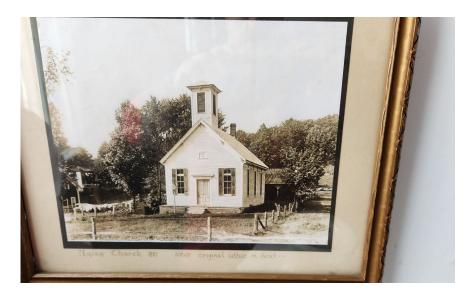
The subject property consists of an existing one-story wood frame building constructed in 1881, formally the Union Church. The exterior wood siding, trim, fascia, soffit, and brackets have obvious signs of paint failure indicated by cracking, peeling, and bubbling on all painted surfaces. Horizontal surfaces susceptible to rain and snow such as the windowsills are mostly bare wood and show signs of deterioration. The exterior wood double-hung windows also exhibit the same paint issues along with missing and dried-out window glazing which exposes the bare wood. The exterior wood doors also have identical paint with defects of a warped door leaf, no weatherstripping, and an exposed wood door threshold that is worn and deteriorated from time and use. These recommendations below are grouped by scope of work which can be separated and completed at different times as monies are available. Any work that is to occur offsite, such as fixing the doors and reglazing the windows, shall have their openings protected from intruders and weather. Exterior primer and paint coating shall be the recommendation of the painting contractor, color to match the existing unless directed otherwise by the owner.

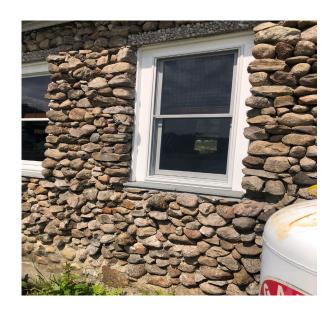
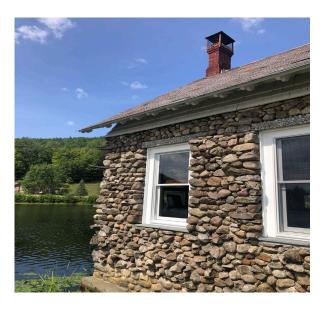
# Exterior Stone Foundation Wall

• There are some stones missing within the dry stack stone wall of the building. Replacement stone of same kind to be installed and set into Type S mortar to match same method as existing.

Cost Estimate = \$1,200.00.

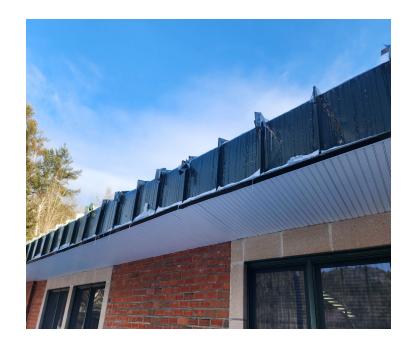
Roof Fascia

The subject building consists of a standing seam roof system that extends down creating the fascia. Over the years manual snow removal has taken its toll on this fascia as there are several areas where the rib corner trim has become un-attached which allows water to enter behind this system. Also, removing snow from this roof has accumulated several dents and scratches which is aesthetically unpleasing for a public building.

Corner Rib Cover Trim torn from the standing seam roof ribs, allowing water to enter the wood fascia substructure

This scope of work includes removal of the standing seam fascia system perimeter of building and replace with a traditional fascia system as indicated on the attached drawing.

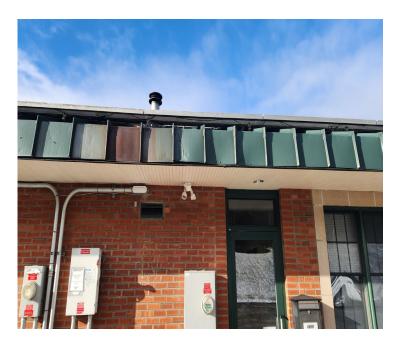
Standing Seam Fascia system is detached from the wood fascia substrate could be caused by water entering from torn corner rib cover trim and deteriorating the wood substrate

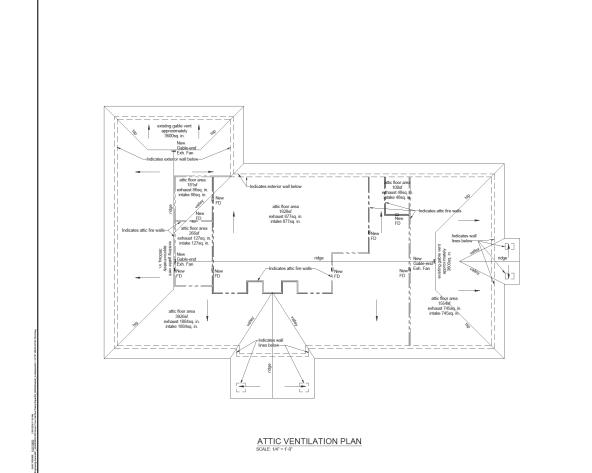
AV-1

This building also has heating, cooling, and ice dam issues which is due to the lack of cross ventilation from the soffit vents to the gable louvers within the attic space. Because of code, there were fire areas designated within the building and these areas were sectioned off utilizing fire-rated walls extending up to the bottom of the roof sheathing. Because these walls extended to the roof sheathing, it sectioned areas off from one another which blocked airflow from venting some of these areas.

This scope of work includes adding fire dampers within the fire-rated walls which allows airflow and installing electric gable vents to draw airflow from the soffit vents to these fans as indicated on the attached drawing.

FIRE DAMPER SCALE: NONE
